4/30 Dulacca Street
Acacia Ridge QLD
Australia

Mould Remediation Report

S8-5079

[REDACTED] St, Mount Lofty Toowoomba,
QLD 4350, Australia

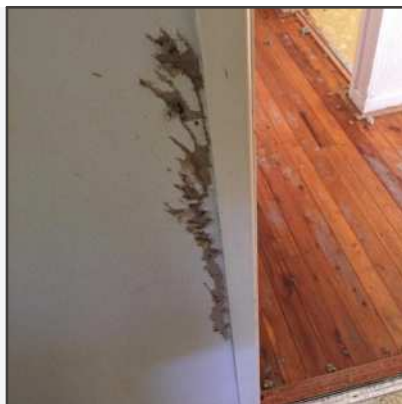
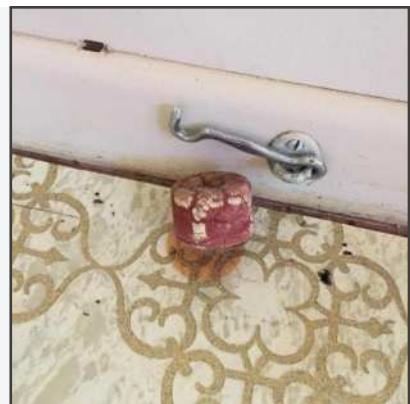
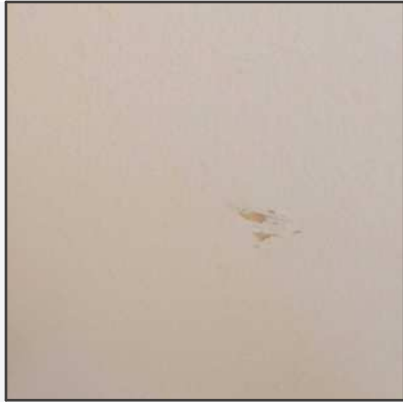
Pre-existing Damages

Relative Humidity: – 63%, 35%

Room Temperature: – 13.8°C, 05.7C

Ceiling Moisture Reading: – 18.0%

Wall Moisture Reading - 17.2%, 10.5%, 11.1%

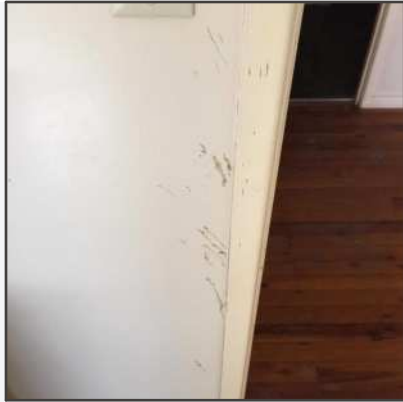
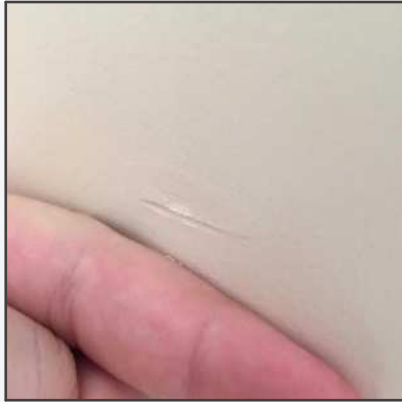
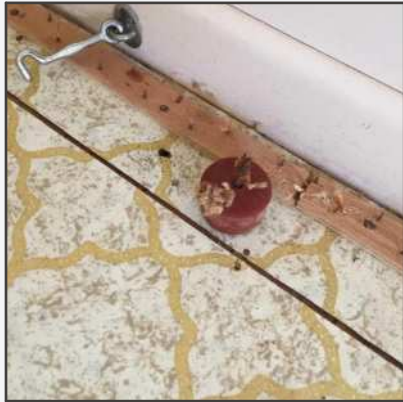
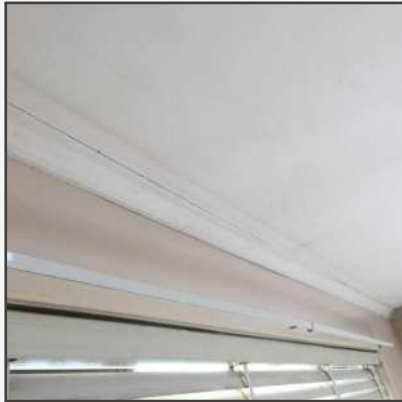
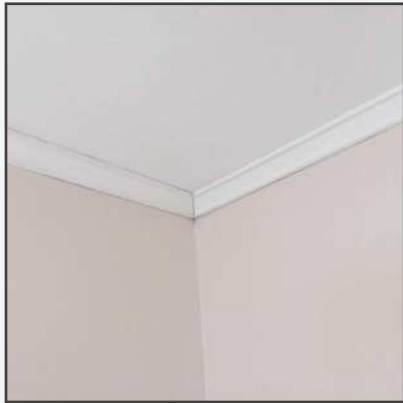
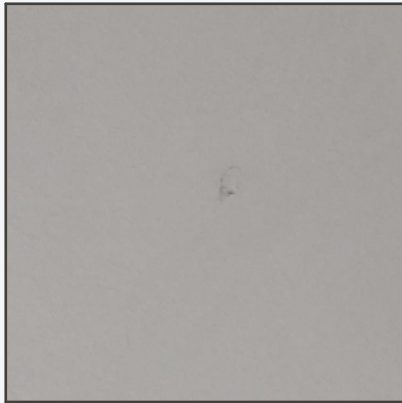
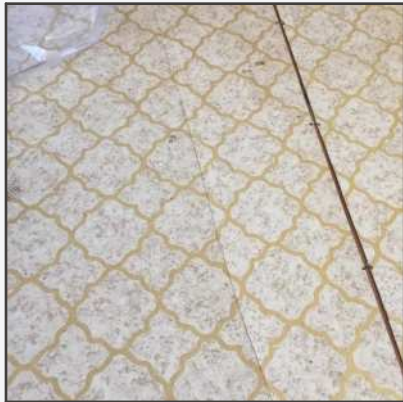
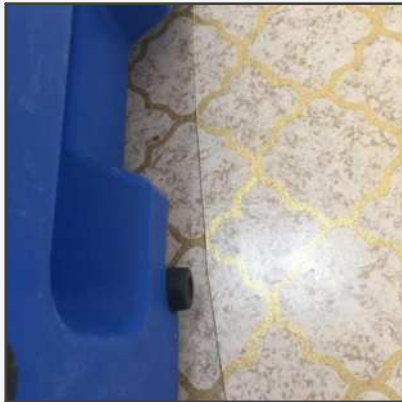
Damage

Relative Humidity: – 62%, 32%

Room Temperature: – 13.9°C, 06.4C

Ceiling Moisture Reading: – 20.7%, 21.8%

Floor Moisture Reading: – 14.2%

Master Bedroom: Install Zipwall containment in the doorway. Set up an air scrubber and HEPA vacuum all surfaces including ceilings, walls, flooring, window frames, and tracks.

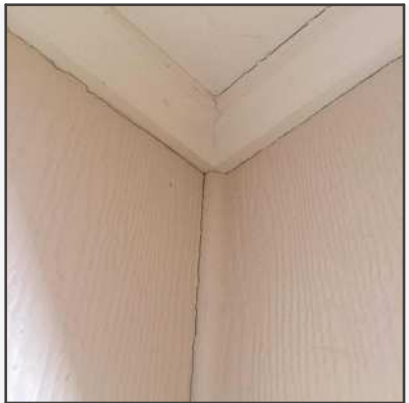
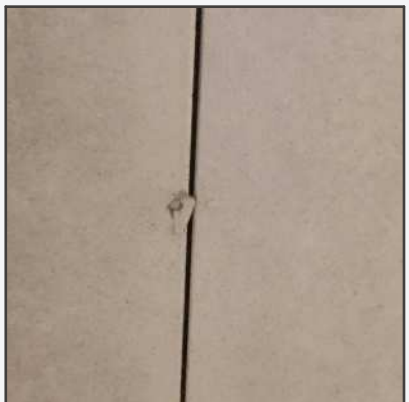
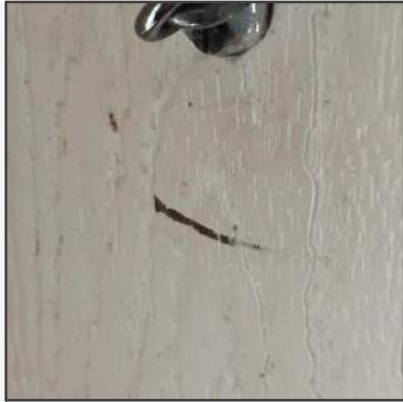
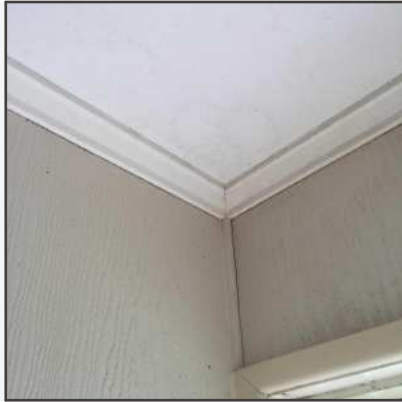
Pre-existing Damages

Room Inspection Initial Attendance:
Room Size (LxWxH):
Moisture & Hygrometer Readings:
Relative Humidity: – 58%, 36%
Room Temperature: – 14.9°C, 05.4C
Ceiling Moisture Reading: – 08.2%
Wall Moisture Reading - 9, 12.5, 10, 13
Floor Moisture Reading - 16.5

Hallway: Set up Zipwall containment at entryways to prevent cross-contamination. Use an air scrubber to capture airborne mould spores.

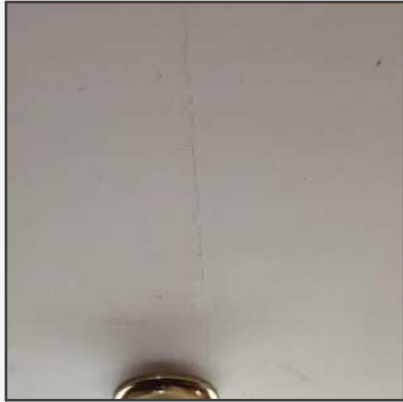
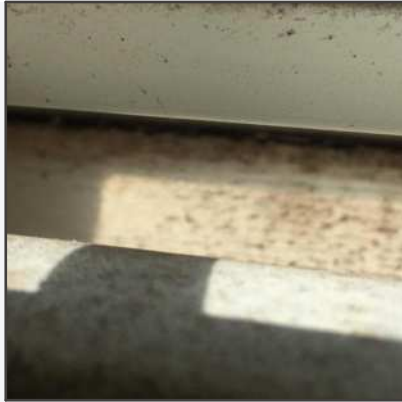
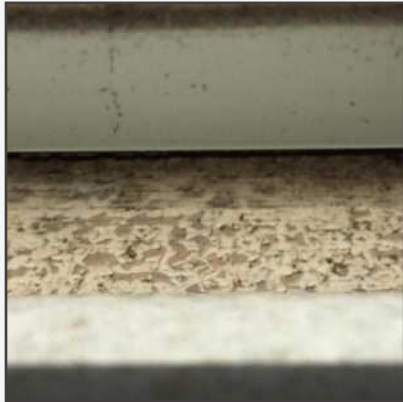
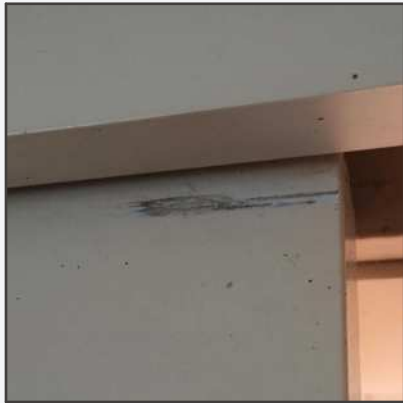
Pre-existing Damages

Relative Humidity: – 63%, 38%

Room Temperature: – 15.0°C, 06.3C

Floor Moisture Reading: – 36.2%, 22.9%, 12.9%, 11.7%, 11.1%

Wall Moisture Reading - 15.1%, 14.3%

Lounge Room: Install Zipwall containment in doorways. HEPA vacuum and clean all surfaces including walls, ceilings, flooring, window frames, tracks, screens, and blinds. Use an air scrubber to catch airborne spores.

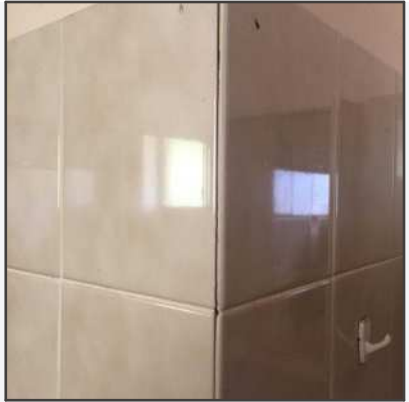
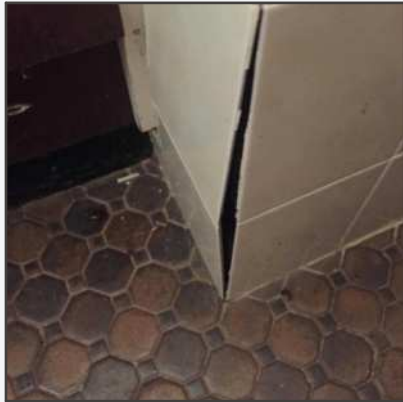
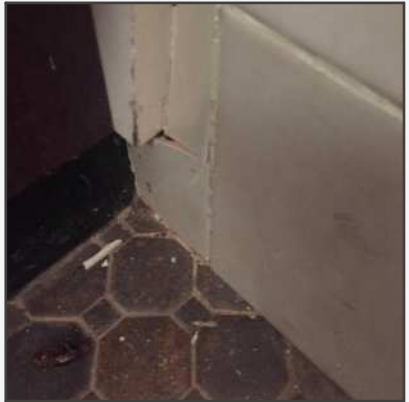
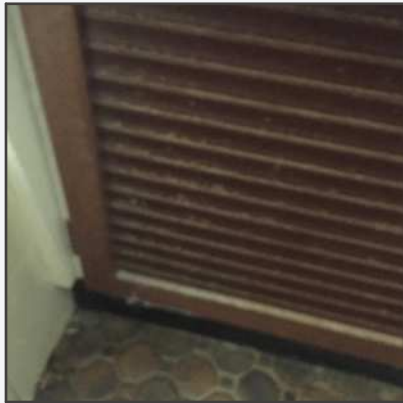
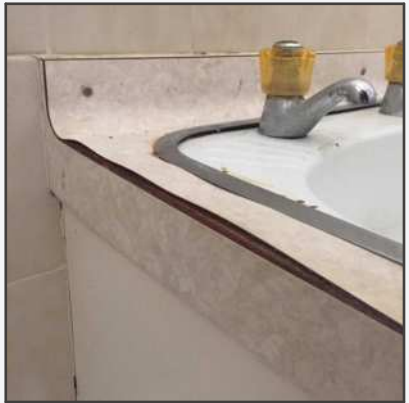
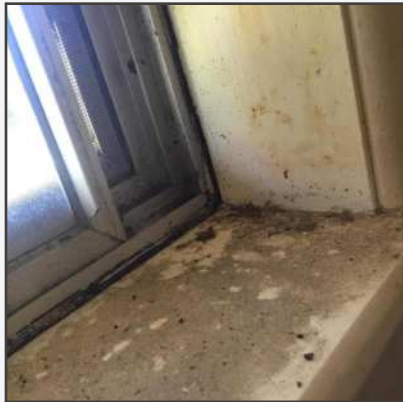
Pre- existing Damages

Extensive surface mould and dust observed on walls and ceilings throughout the property. Significant mould growth on the bathroom ceiling, causing non-restorable damage to the cornice.

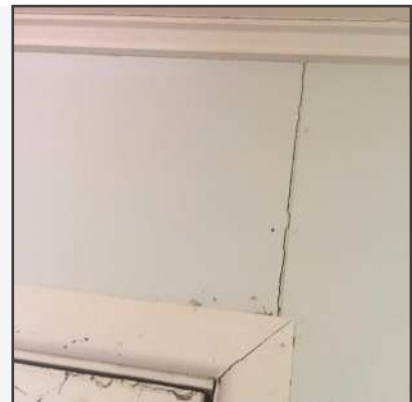
Pre-existing Damages

Wall Moisture Reading: – 26, 26.5, 18.5, 24.9, 25
