4/30 Dulacca Street
Acacia Ridge QLD
Australia

Mould Remediation Report

S8-5079

[REDACTED] St, Mount Lofty Toowoomba,
QLD 4350, Australia

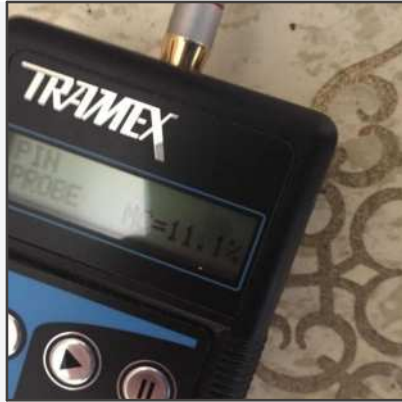
Hygrometer Readings

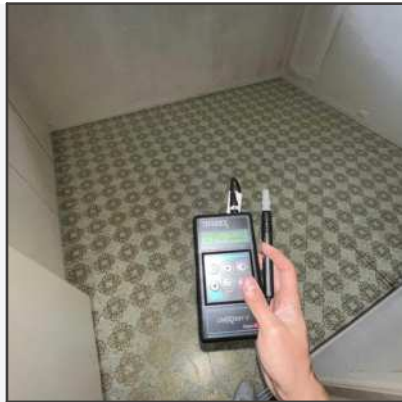
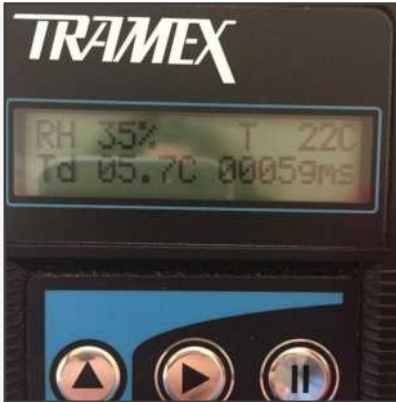
Pre-existing Damages

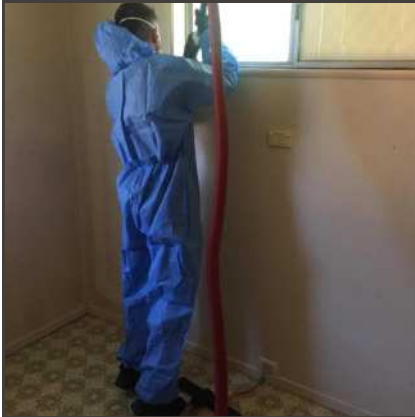
Hepa vac

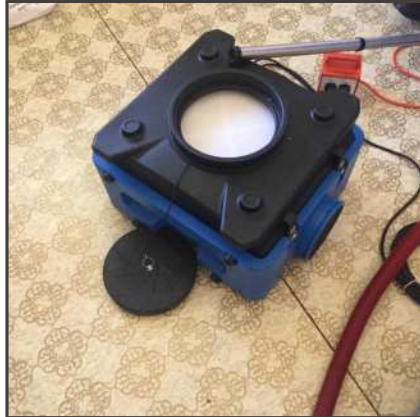
Afd

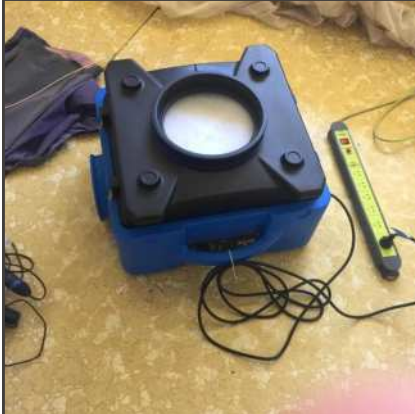
Afd

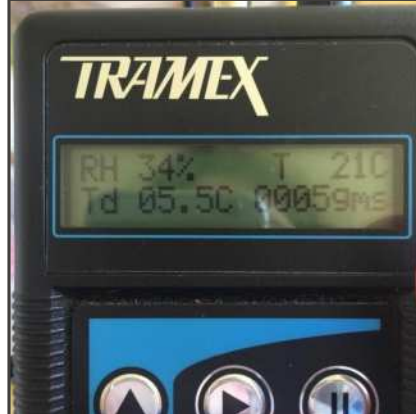
Hygrometer

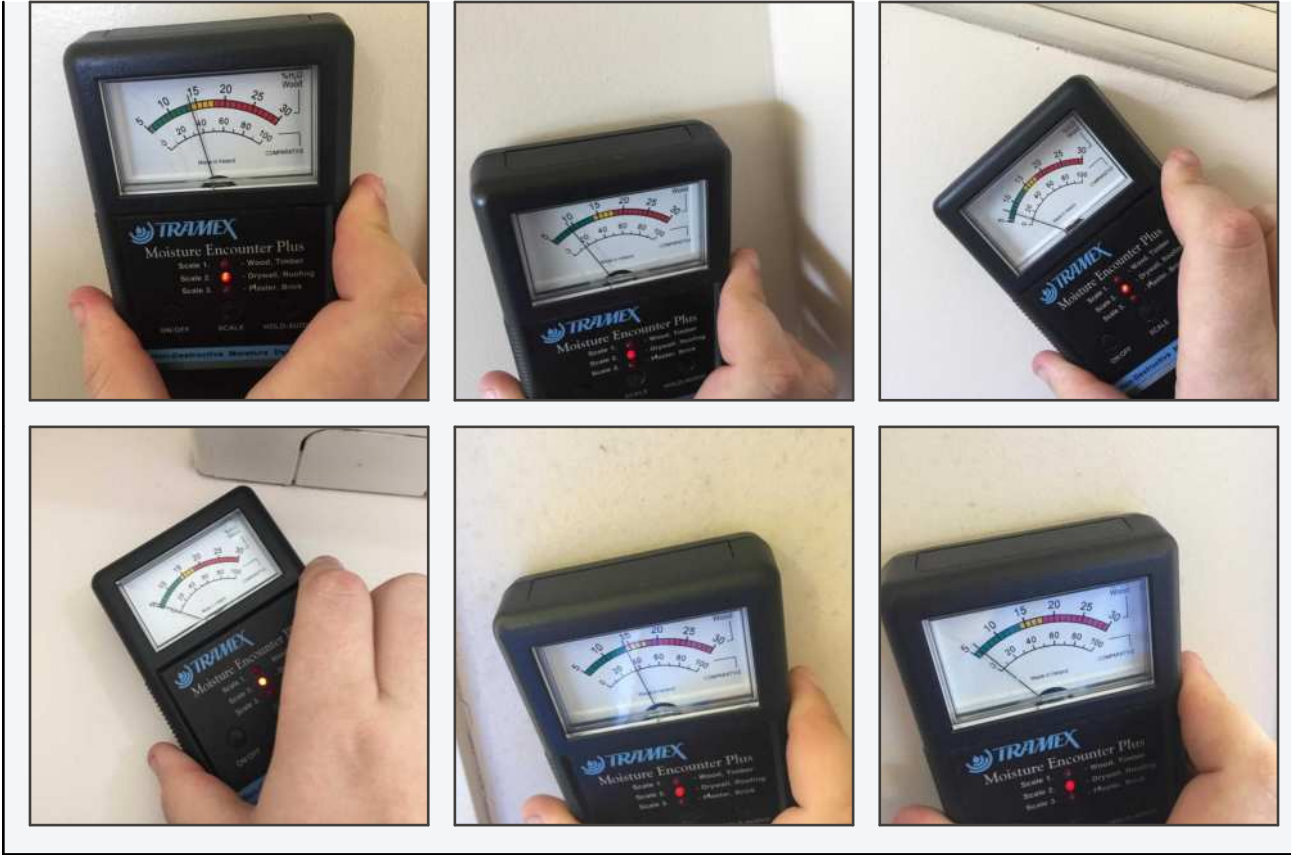
Moisture & Hygrometer Readings:

Relative Humidity: – 62%, 32%

Room Temperature: – 13.9°C, 06.4C

Ceiling Moisture Reading: – 20.7%, 21.8%

Floor Moisture Reading: – 14.2%

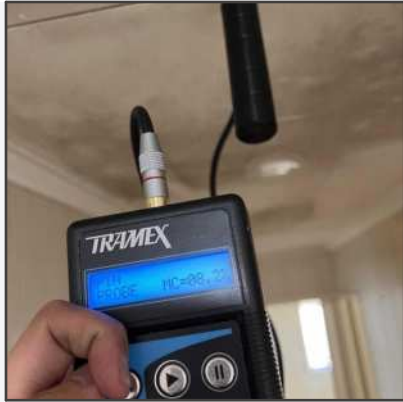
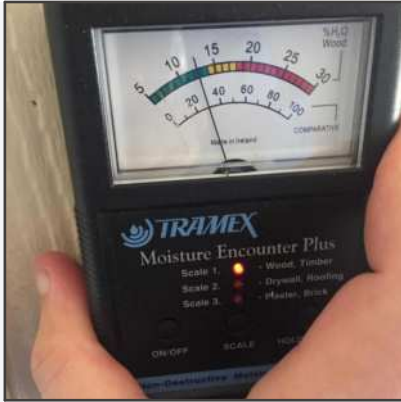
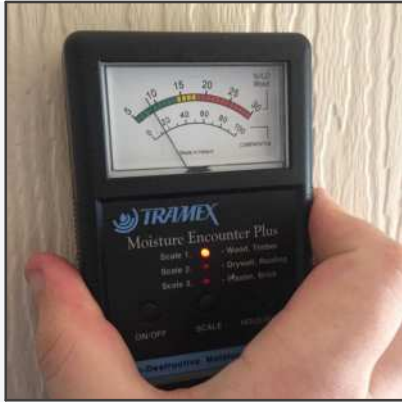
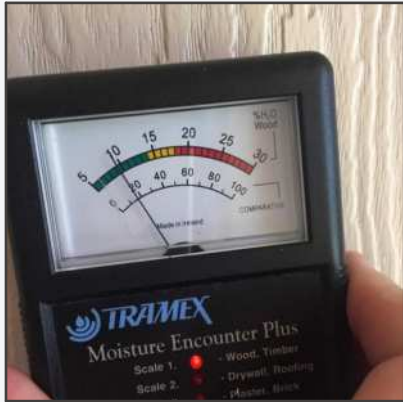
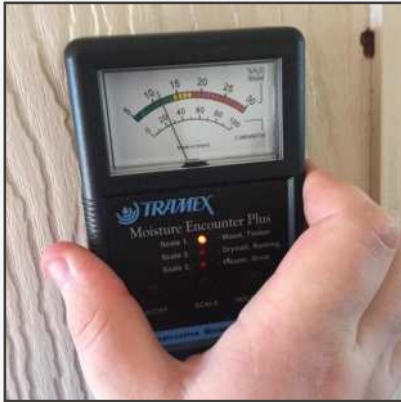
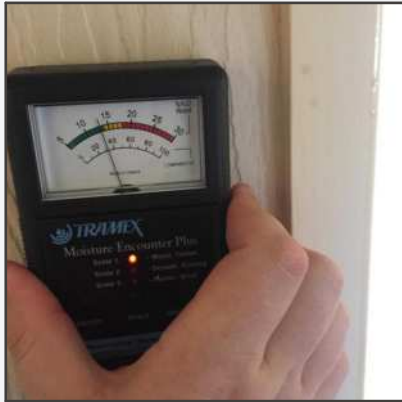
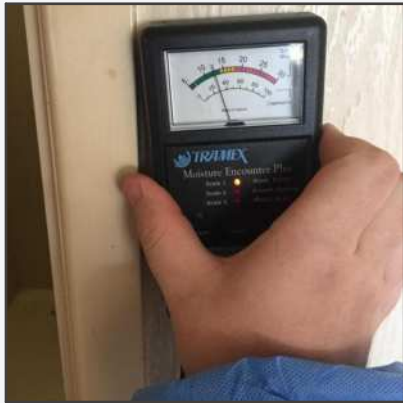
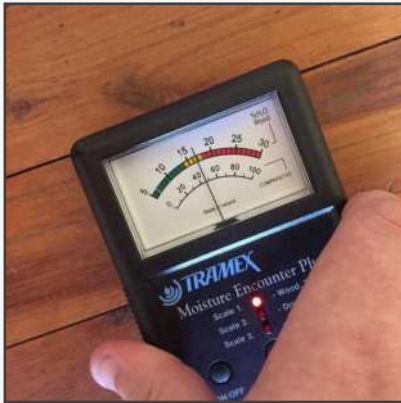
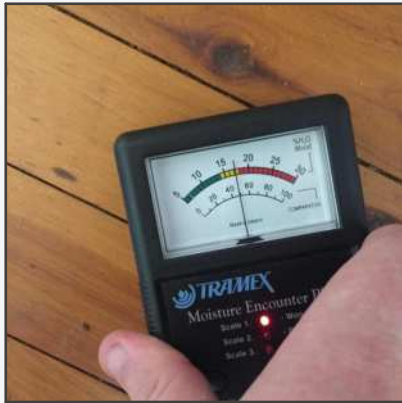
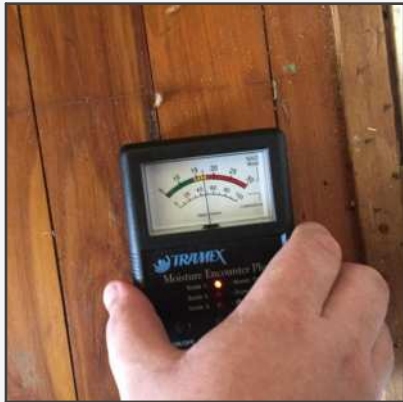
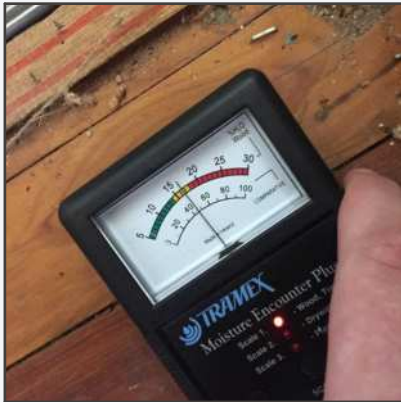
16/8/2024- Room Inspection Initial Attendance

Room Inspection Initial Attendance:
Room Size (LxWxH):
Moisture & Hygrometer Readings:
Relative Humidity: – 58%, 36%
Room Temperature: – 14.9°C, 05.4C
Ceiling Moisture Reading: – 08.2%
Wall Moisture Reading - 9, 12.5, 10, 13
Floor Moisture Reading - 16.5

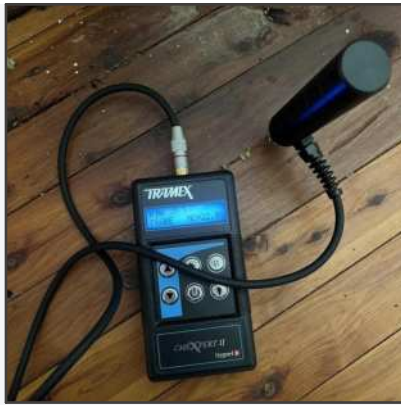
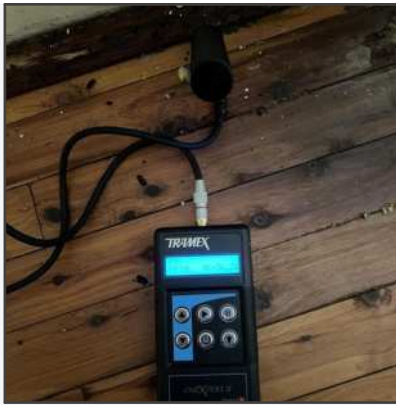
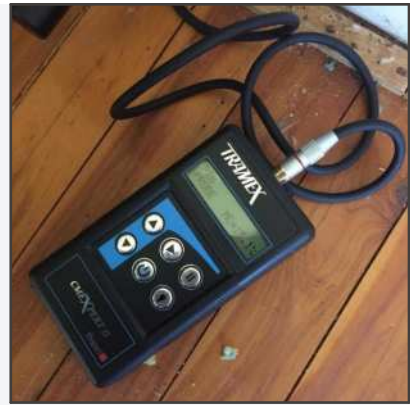
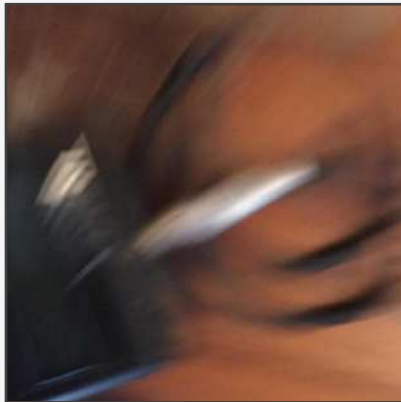
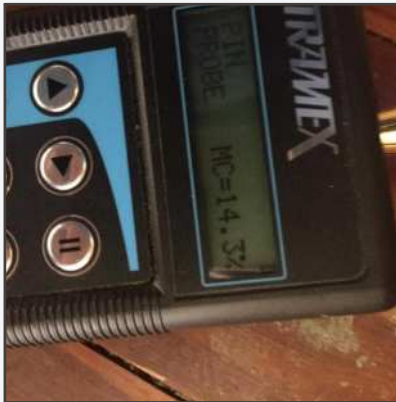
Relative Humidity: – 63%, 38%

Floor Moisture Reading: – 36.2%, 22.9%, 12.9%, 11.7%, 11.1%

Wall Moisture Reading - 15.1%, 14.3%

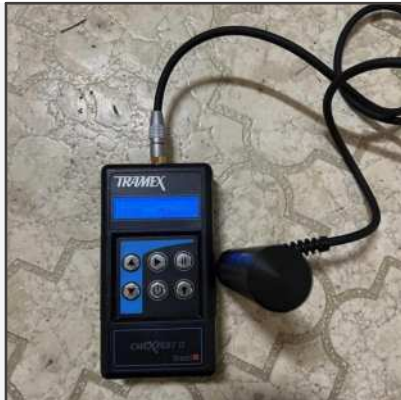
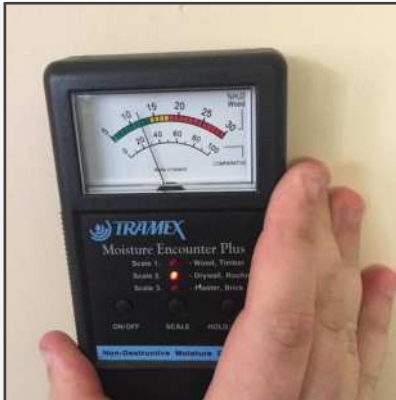
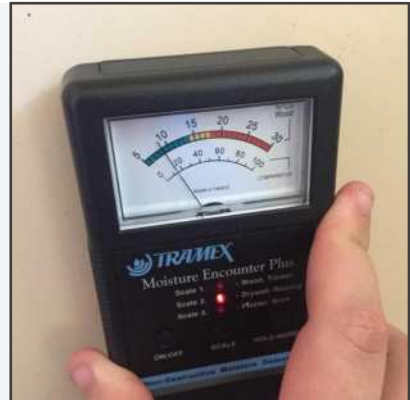
Room Inspection Initial Attendance:
Room Size (LxWxH):
Moisture & Hygrometer Readings:
Relative Humidity: – 38%
Room Temperature: – 05.5C
Wall Moisture Reading: – 9.5, 10
Floor Moisture Reading: – 12.7, 34.3, 32.5, 33.7

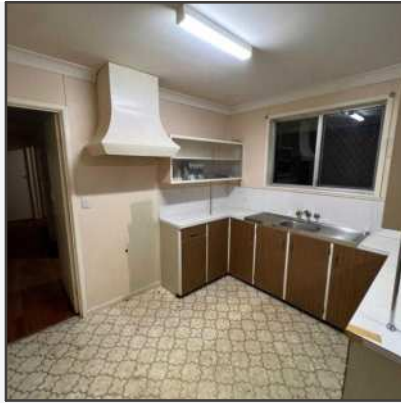
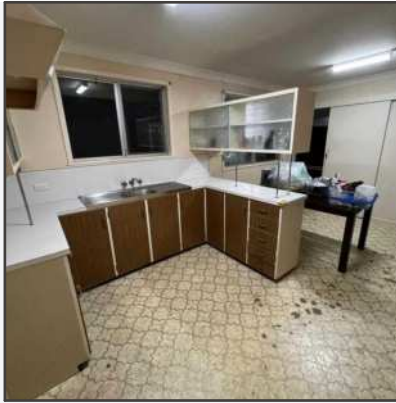
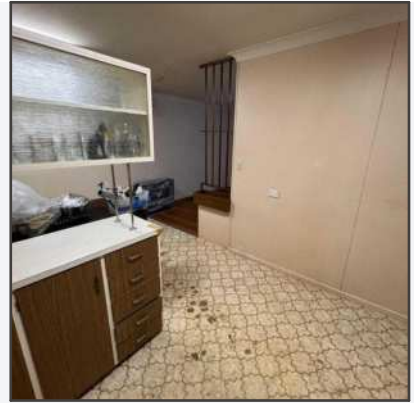
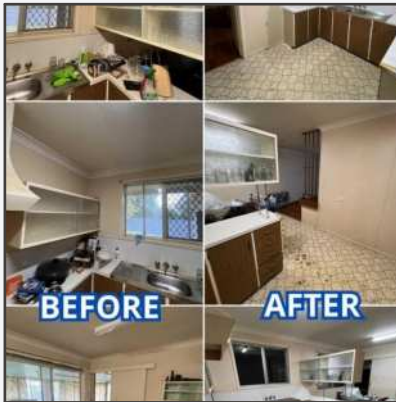
After Photos

12/09/2024 - Room Inspection Re-Attendance

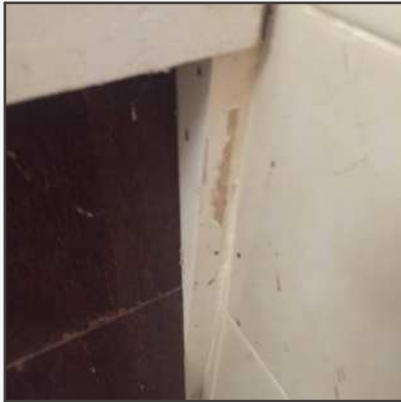
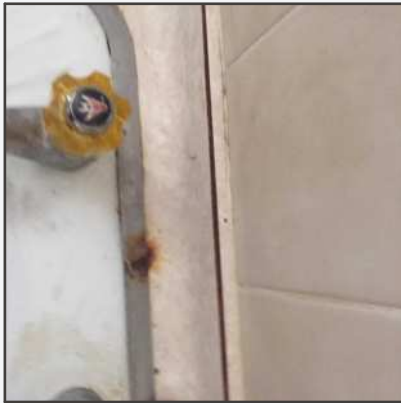
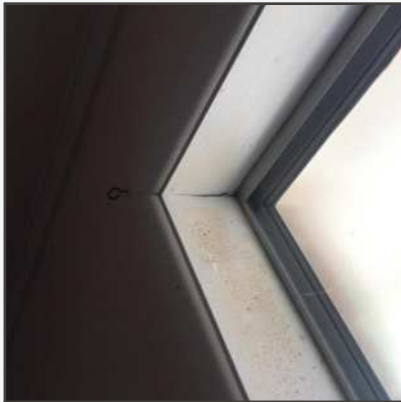
Room Notes: Bathroom

Pre- existing Damages

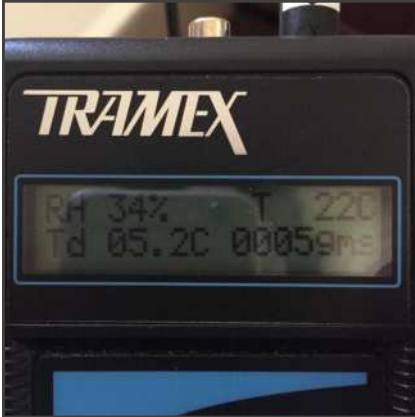
Hygrometer

Relative Humidity: – 34%

Room Temperature: – 05.2C

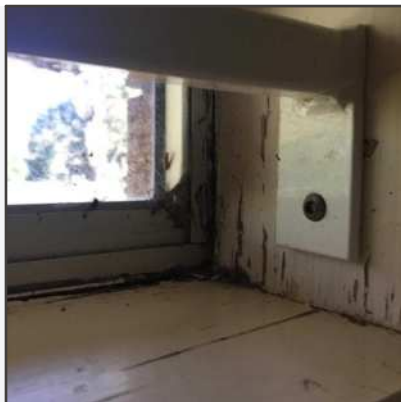
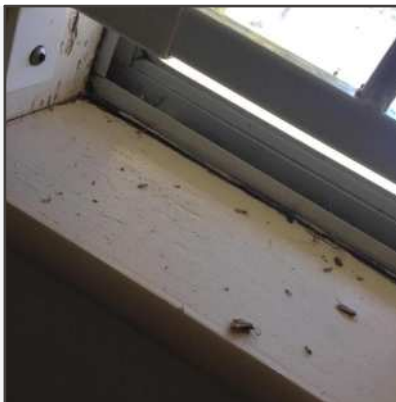
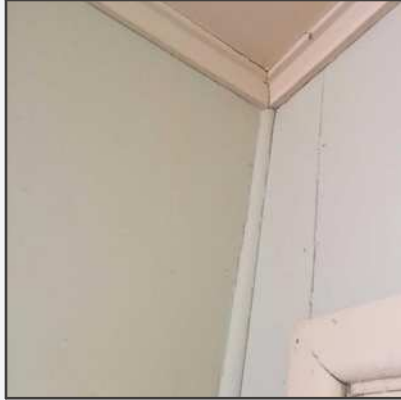
Room Notes: Laundry Room

Pre-existing Damages

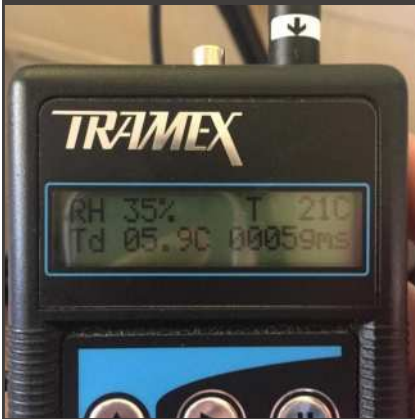
Hygrometer

Relative Humidity: – 35%

Room Temperature: – 05.9C

Wall Moisture Reading: – 26, 26.5, 18.5, 24.9, 25

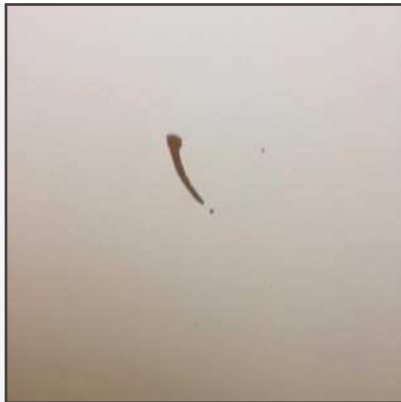
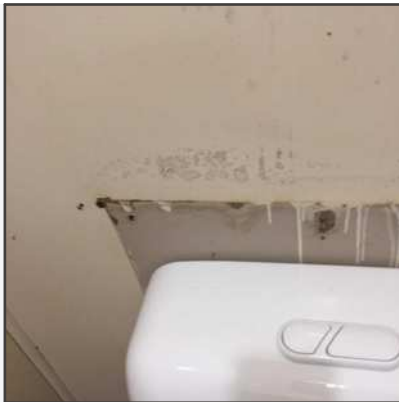
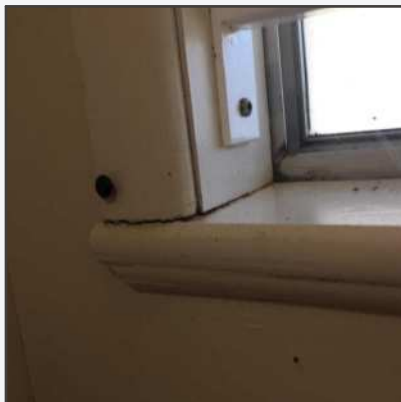
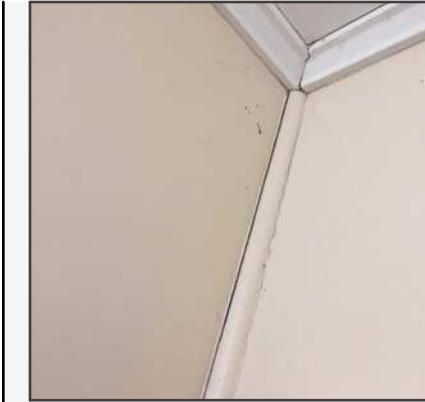
Room Notes: Toilet

Pre-existing Damage

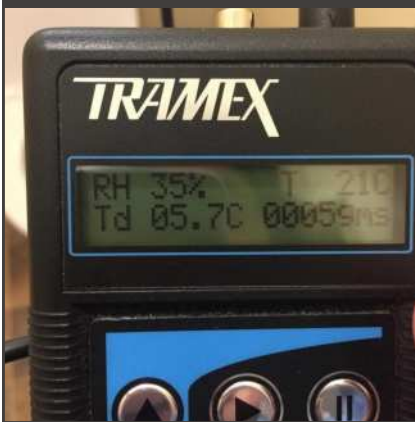
Hygrometer

Relative Humidity: – 35%

Room Temperature: – 05.7C

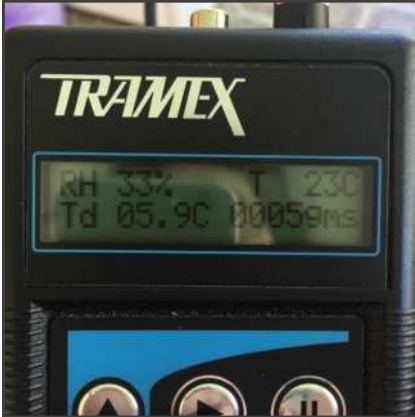
Hygrometer

Relative Humidity: – 33%

Room Temperature: – 05.9C

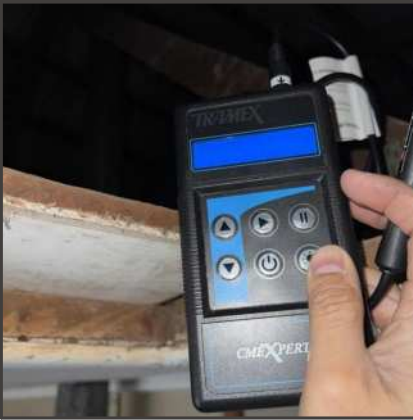
Hygrometer Readings

Moisture & Hygrometer Readings:
Relative Humidity: – 72%
Room Temperature: – 14.2°C
